## Commonwealth Bank

Metcalfe Constructions were engaged to rectify the foundations and repair all visual damage to the external façade of the old Commonwealth Bank building in Maryborough and restore the building to its' original condition.

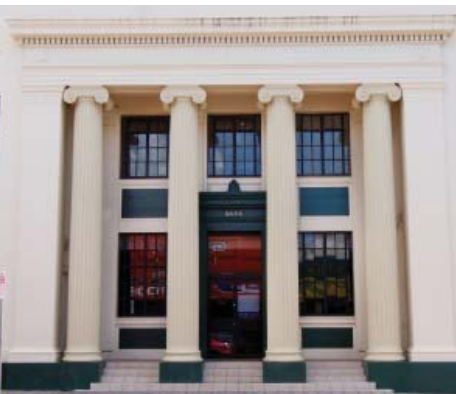
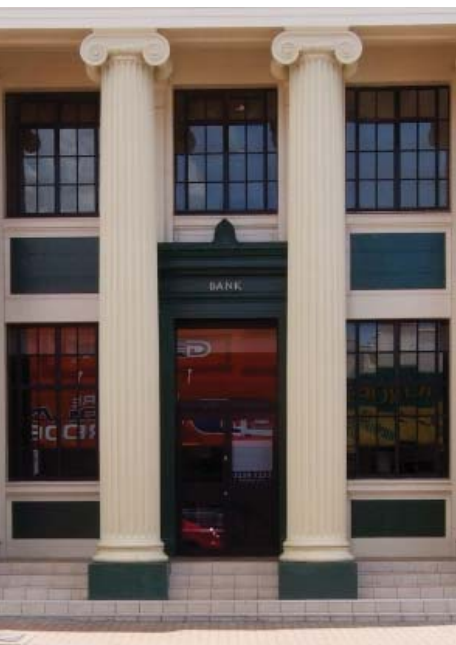
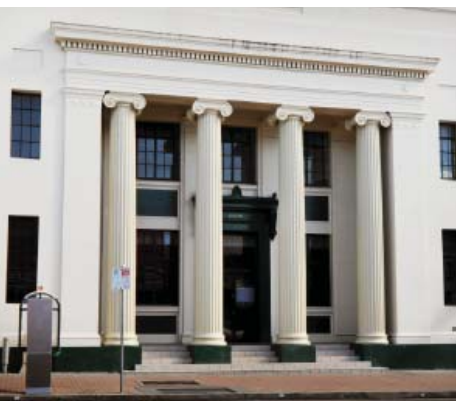
The existing foundations had subsided causing structural damage to supporting beams, pillar caps were crumbling and various elements were deteriorating.

The Metcalfe Constructions Project Team arranged for engineered steel posts and plates to be fixed to the supporting beams without comprising the internal appearance.

Externally the building was given new pillar caps, repairs were carried out to the cement render as well as repainting and removal of the unsympathetic later additions.
